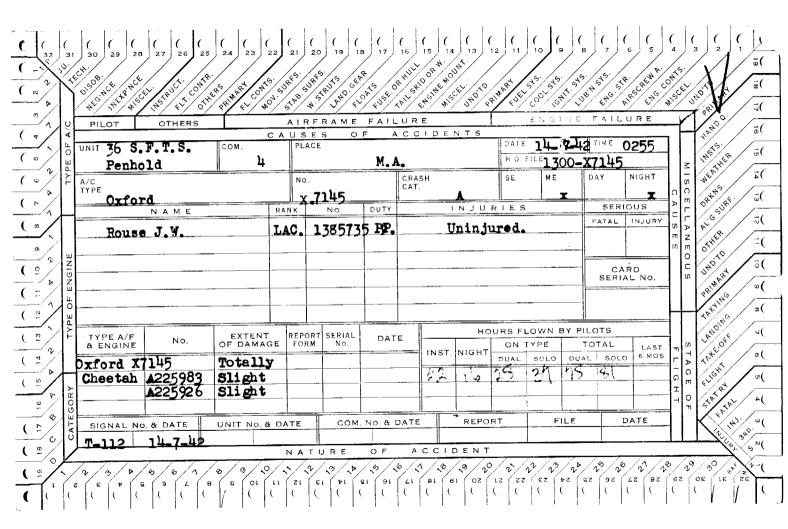
Solo night flying prac		Y, INVESTIGATING OFFICER OFFICER'S REPORT:	
NATURE OF ACCIDENT AND STAGE (		20/100/POM	
pressure was low, inten	ided to land	7	
as near No.1 flare as p in so doing undershot, s			
fence causing it to nose	forward and RECOMMENDATIO	NS:	
finally turn over.  PRIMARY CAUSE:			
below the minium require	ed in Station		
Standing Orders.  3 Sudushot	ACTION TAKEN:  (A) DISCIPLINA  Disciplina	RY (B) TECHNICAL (C) OTHER Ary action taken - log book ende edience." has been made.	orsement
Standing Orders.	ACTION TAKEN:  (A) DISCIPLINA  Disciplina	ary action taken - log book endedience." has been made.	orsement
Standing Orders.	ACTION TAKEN:  (A) DISCIPLINA  Discipling  of "Dosobe  14 days C	ary action taken - log book endedience." has been made.	orsement
Standing Orders.  3 Ludushot  SECONDARY CAUSE OR CONTRIBUTI  Aircraft struck a wire causing it to nose forw turn over.	ACTION TAKEN:  (A) DISCIPLINA  Discipling  of "Dosobe  14 days C	ary action taken - log book endedience." has been made.	orsement

Standing Orders.  3 Sudushot  SECONDARY CAUSE OR CONTRIBUTION  Aircraft struck a wire causing it to nose forw	ACTION TAKEN:  (A) DISCIPLINA  Discipling  of "Dosobe  14 days C	ary action taken - log book endedience." has been madeB.
