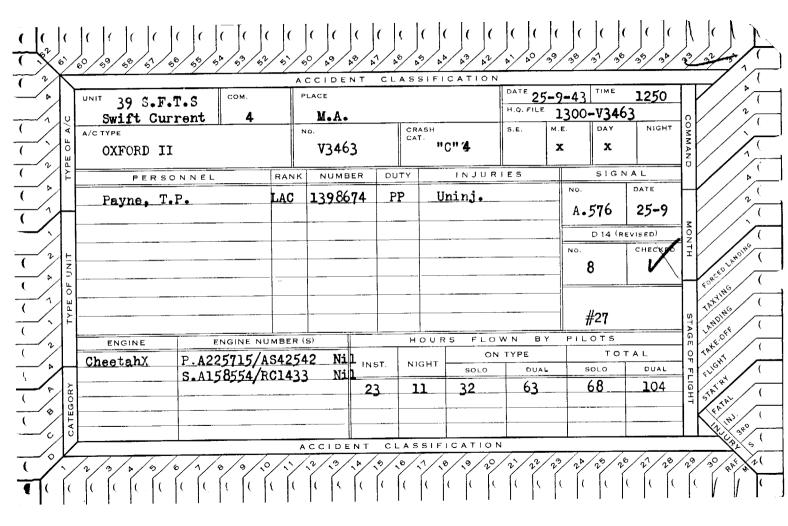
PURPOSE OF FLIGHT:	TECHNICAL OFFICER'S REPORT:)
NATURE OF ACCIDENT:	Examination revealed that both sets of radius rods had been damaged due it is considered to a previous landing.)
'After completing authorized solo fli	ghtourt of inquiry or investigating officer's report)
) bobit tonud cust ale Monita not Tock	FINDINGS: SUMMARY No.)
down when he returned to aerodrome.		ì
After trying emergency system pupil	LUCKUPD	,
) signalled to ground that he was in difficulty and then came into land.	200/0/2)
Upon landing port u/c leg collapsed	and)
at end of run a/c settled down on po	rt	
) wing tip.		`
)		
, , , , , , , , , , , , , , , , , , ,)
CLASSIFICATION:)
) 21 II/C down but not 6,732, 7 12)

31. U/C down but not fully locked.	5	ì
) a facture		
SECONDARY OR CONTRIBUTORY FACTORS:		,
33. Technical defect.	ACTION TAKEN:)
35 W/C Defect. 26	ACTION TAKEN:)
) 93	Nil	
R.C. A. F. L 20 (REVISED) 7M-4-43 (3202) K. P. 5051
