R. C. A. F. L 20 (REVISED) 7M-4-43 (3202) K. P. 5051 H. Q. 885-L 20

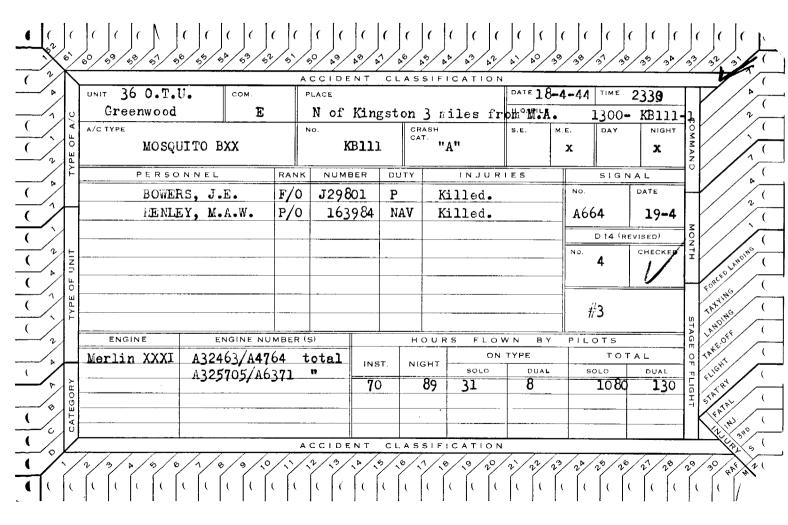
PURPOSE OF FLIGHT: S.R. "C" searchlight practice. NATURE OF ACCIDENT: Pilot dived from about 3.000 the height for which he was briefed. to 800' where he commenced to turn. He was considered to be dangerously low. so the searchlight was douced. the a/c was seen to reach a 90° angle of bank and dive in. CLASSIFICATION:

TECHNICAL OFFICER'S REPORT: NT L COURT OF INQUIRY OR INVESTIGATING OFFICER'S REPORT: SUMMARY No. 2335 FINDINGS: CIRCUMSTANCES: While flying too low a/c carried out violent evasie action in searchlight exercise, lost control, overcorrected, and flew into the ground but did not burn. CAUSE: Although the cause must remain obscure it is considered that the pilot became temporarily blinded by the searchlights, lost control (perhaps through the lag in the horizon indicator misjudged his altitude) over-corrected into stall and crashed) RECOMMENDATIONS: A more clearly defined station flying order concerning searchlight exercises might be helpful CONCLUSIONS OF A.I.B. Agree with findings. NOTE 1: The I.O. found that G.A.P. 100, Sec 3, para 27 had not been complied with in connection with that a/c, its compass was last swung on the 8th December, 1943. NT L
