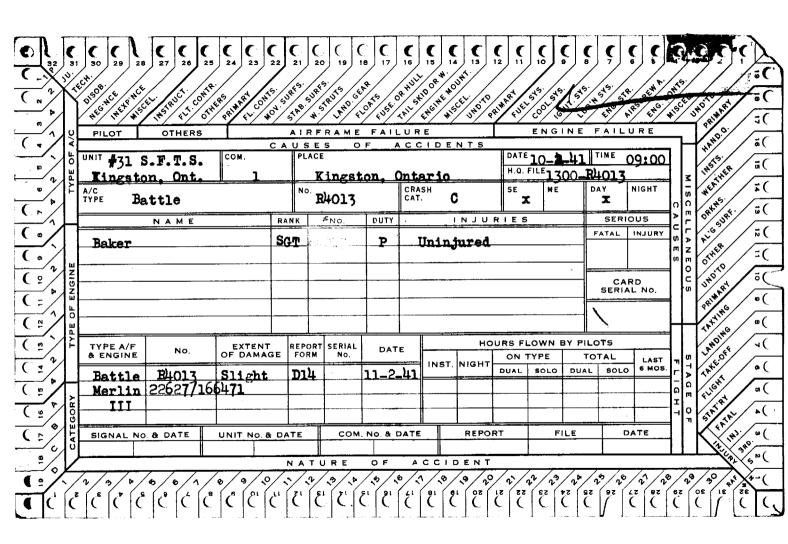
, ) )	SECONDARY CAUSE OR CONTRIBUTING FACTORS:	(A) DISCIPLINARY (B) TECHNICAL (C) OTHER	)
	PRIMARY CAUSE: The slip stream from R. 7440 caused R. 4013 to turn.	This accident is the result of lack of air sense.  Any pilot who Taxi's immediately behind another aircraft whose engine is running strongly is guilty of carelessness. Log Book entry made "Carelessness; Taxi-ing".  ACTION TAKEN:	3
	DUTY ON WHICH ENGAGED:  Air Tests.  NATURE OF ACCIDENT AND STAGE OF FLIGHT: Taxying behind aircreft R7440 whilst it was being run up by Cpl. Woodburn. Application of brakes caused the aircraft to tip on its nose damaging	COURT OF INQUIRY, INVESTIGATING OFFICER OR COMMANDING OFFICER'S REPORT:  Commanding Officers Report.  DATE: 11-2-41  COMPOSITION:  (A. Shekleton) Group Captain.  RECOMMENDATIONS:	<b>3</b>
