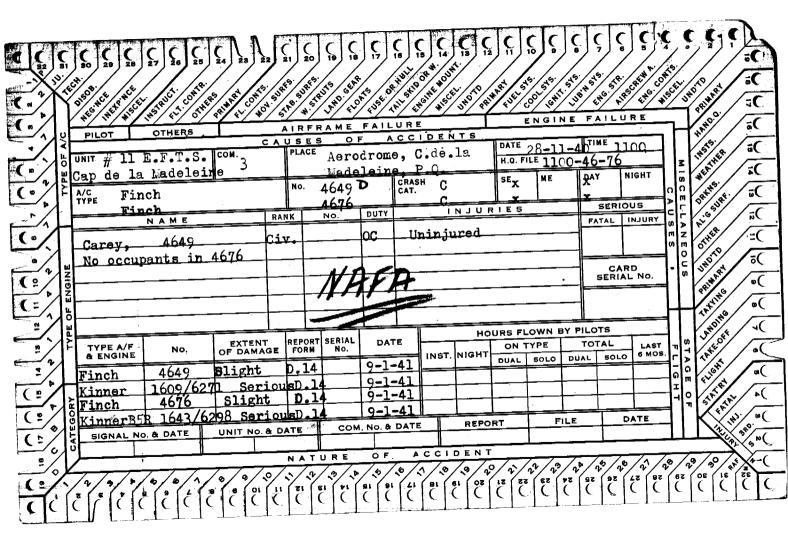
being warmed up by apprentice mechanic Carey. NATURE OF ACCIDENT AND STAGE OF FLIGHT: The apprentice mechanic had the switches in the ON position when the starter battery was being plugged in by another mechanic. The aircraft lunged forward and collided head on	RECOMMENDATIONS: Stricter supporting a .
PRIMARY CAUSE: Ignorance on the part of the apprentice mechanic. Negligence on the part of the operating company in not strictly supervising inexperiemechanics.	C.S.C. inform the Manager of the Operating Company that every step should be taken to ensure proper supervision of the staff. CION TAKEN:
) SECONDARY CAUSE OR CONTRIBUTING FACTORS:	(A) Disciplinary (B) Technical (C) Other .14 approved by A.M.T. 21-1-41.
)))))))))))))))))	CHECKED BY DATE)
